SECTION 32 PROGRAM
STREAMBANK EROSION CONTROL
EVALUATION AND DEMONSTRATION
WORK UNIT 2-EVALUATION OF EXISTING
BANK PROTECTION

FIELD INSPECTION OF SITES IN THE
MISSOURI RIVER DIVISION

October 1980

Inspection Report 10

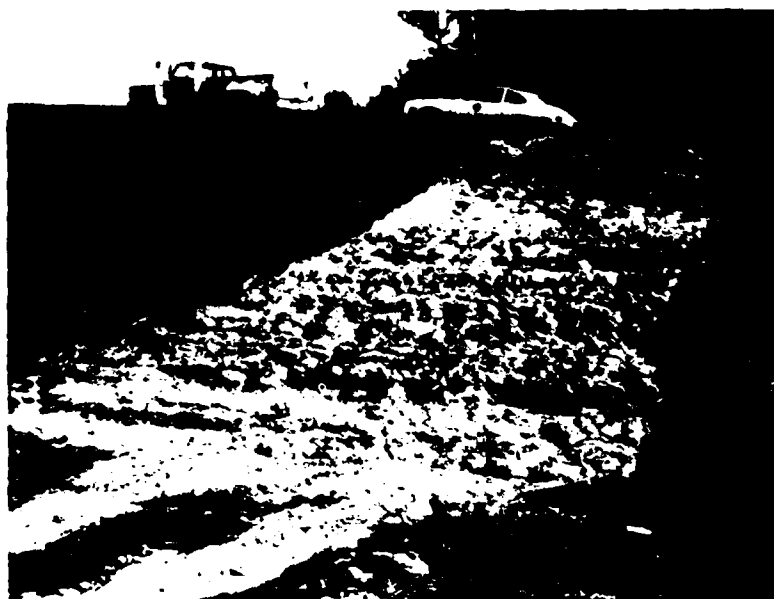
12. The flood of record in September 1977 (17,000 cfs) caused no damage to any of the structures in the Stage I reach. Collection of excessive debris has occurred behind some of the sheet piling and rock sills (Figure 10). MRK personnel report that as a result of uncontrolled overbank drainage, clay blanket erosion has occurred at some locations (Figure 11). At the time of the WES inspection visit, the overall project was in an as-built condition (Figure 12). MRK visits to the Stage I reach through January 1980 indicate that the bank protection measures are performing well; the only problem noted has been surface erosion of the clay blankets.

Figure 11. Little Blue River at Independence, Mo. As a result of uncontrolled overbank drainage, clay blanket erosion has occurred at some locations (May 1977)

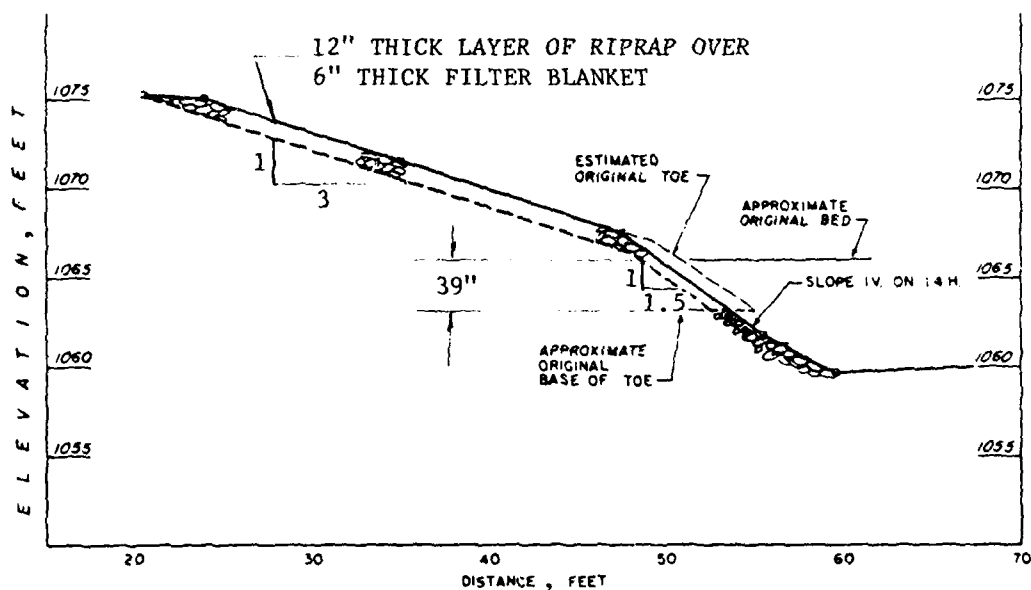
31. Three to 3-1/2 ft of degradation had occurred below the original base of the toe of Test Section 1. The surveyed cross section indicated that the entire riverward face of the toe had receded as the riprap moved downward and adjusted to the degradation (Figure 20). The toe rock had covered the lower slope quite well; however, there was some evidence of separation in the vicinity of the original base of the toe. Since there was little or no stone reserve remaining in this toe, the team concluded that progressive failure of the lower slope protection could occur if there were additional significant degradation.

Figure 20. Republican River at Milford Dam Outlet Channel, Kans. Cross-sectional view of Test Section 1 shown as constructed in 1969 and as surveyed in 1974. (Adapted from Reference 9)

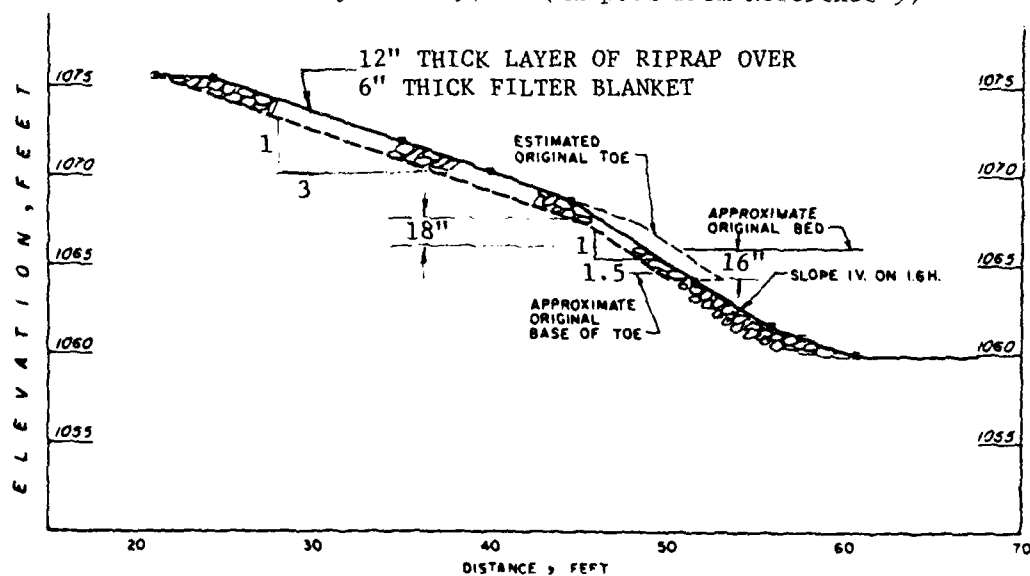
32. Approximately 4-1/2 ft of degradation below the original base of the toe had occurred in Test Section 2 (Figure 21). Riprap had covered the lower slope to a thickness of approximately two rock diameters. There appeared to be some evidence of separation along the original base elevation of the toe as a line of exposed bedding could be seen along the entire length of the test section.

Figure 21. Republican River at Milford Dam Outlet Channel, Kans. Cross-sectional view of Test Section 2 shown as constructed in 1969 and as surveyed in 1974. (Adapted from Reference 9)

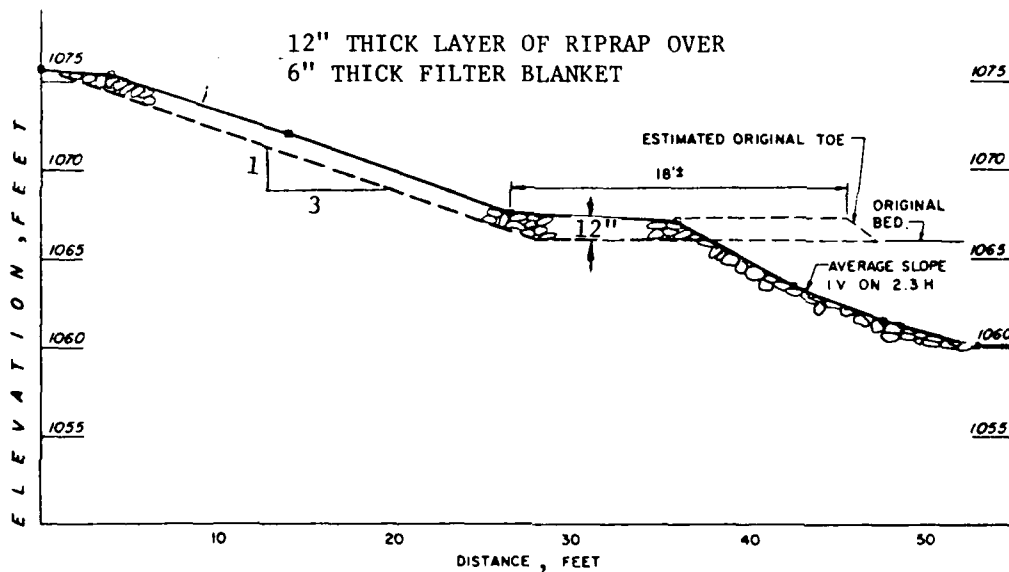
33. The streambed in the vicinity of the toe of Test Section 3 had degraded approximately 6 ft (Figure 22). The riprap had moved downward to cover the lower slope; however, the thickness averaged somewhat less than one rock diameter, i.e., small areas of exposed sand could be seen over the entire face of the toe. There was a substantial reserve of stone remaining in the toe; however, the MRK inspection team noted that if additional degradation occurred too rapidly, partial revetment failure could occur due to separation of the thin blanket. Alternatively, recession of the bank by leaching could cause additional riprap to move downward from the reserve and form a thicker bank covering.

Figure 22. Republican River at Milford Dam Outlet Channel, Kans. Cross-sectional view of Test Section 3 shown as constructed in 1969 and as surveyed in 1974. (Adapted from Reference 9)

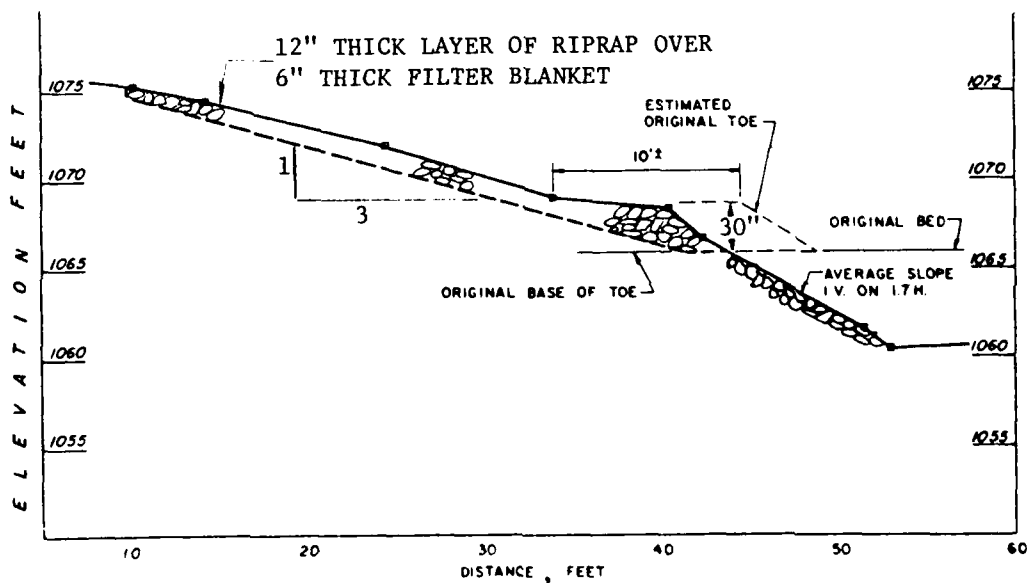
34. Approximately 5 ft of degradation had occurred along the toe of Test Section 4 (Figure 23). There was a uniform blanket of riprap on the lower slope averaging at least two rock diameters thick. No evidence of blanket separation or areas of exposed bed material were noted. The riverward edge of the stone was essentially at the base of the slope

Figure 23. Republican River at Milford Dam Outlet Channel, Kans. Cross-sectional view of Test Section 4 shown as constructed in 1969 and as surveyed in 1974. (Adapted from Reference 9)

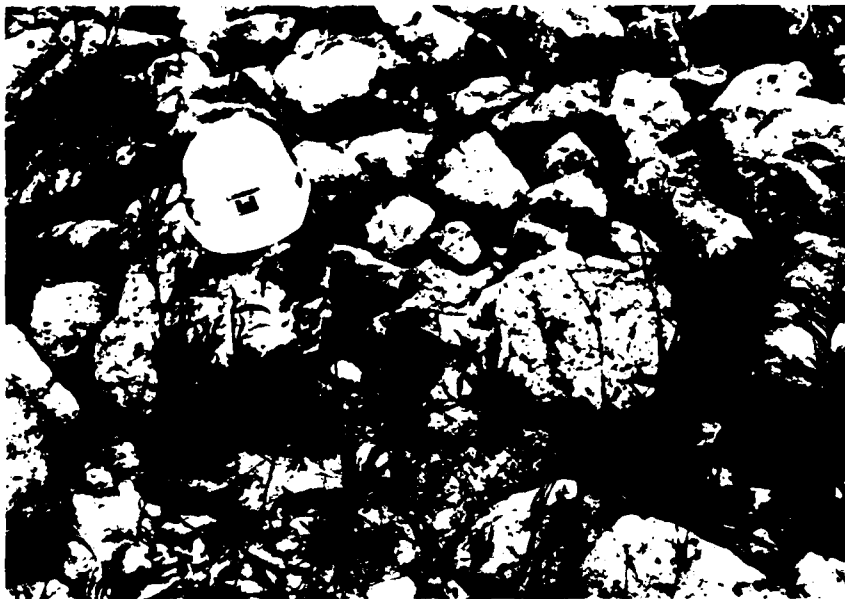
exposed areas between individual rocks. This was typical of the slope below the 12-in.-thick horizontal blanket in Test Section 3 (Figure 26) and isolated areas over Test Sections 1 and 2 (Figure 27). Good coverage of riprap on the slope below the 30-in.-thick horizontal blanket was noted in Test Section 4 (Figure 28). No areas of exposed sand could be found in this test section. A substantial growth of willows, cottonwoods, and other woody vegetation had developed over Test Section 3 (Figure 29). The team concluded that this growth could retard the downward movement of rock from this test section and that in order to retain a valid test, the vegetation should be removed. Breakdown of stone on the left bank near the waterline was noted. This was due to exposure to the sun during the winter and the resulting range of temperature variation that the riprap experienced; however, the extent of deterioration was not considered sufficient to affect the integrity of the revetment.

Figure 26. Republican River at Milford Dam Outlet Channel, Kans. Areas of exposed sand visible between individual rocks below the 12-in.-thick horizontal blanket in Test Section 3 (May 1977). (Source: Reference 11)

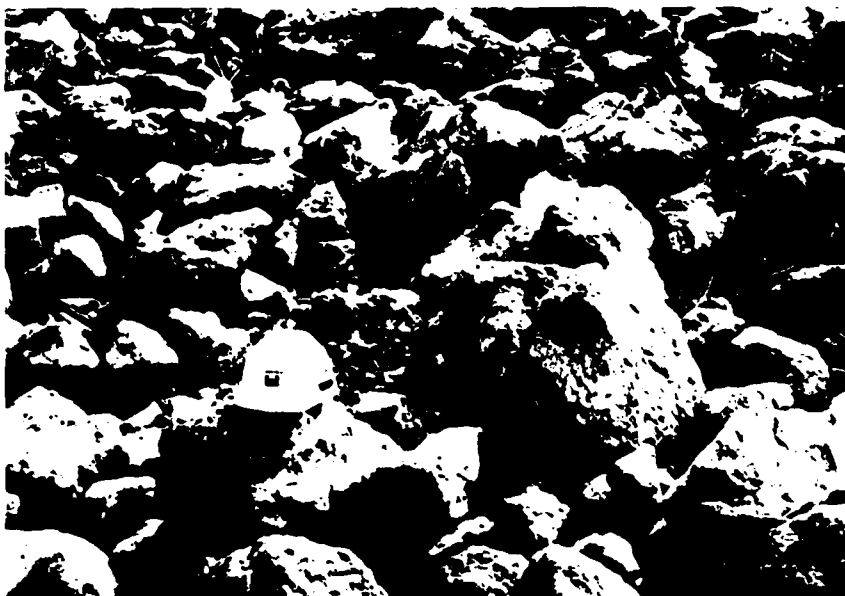
Figure 27. Republican River at Milford Dam Outlet Channel, Kans. The area behind the hard hat is typical of the isolated areas of exposed bedding material in Test Sections 1 and 2 (May 1977). (Source: Reference 11)

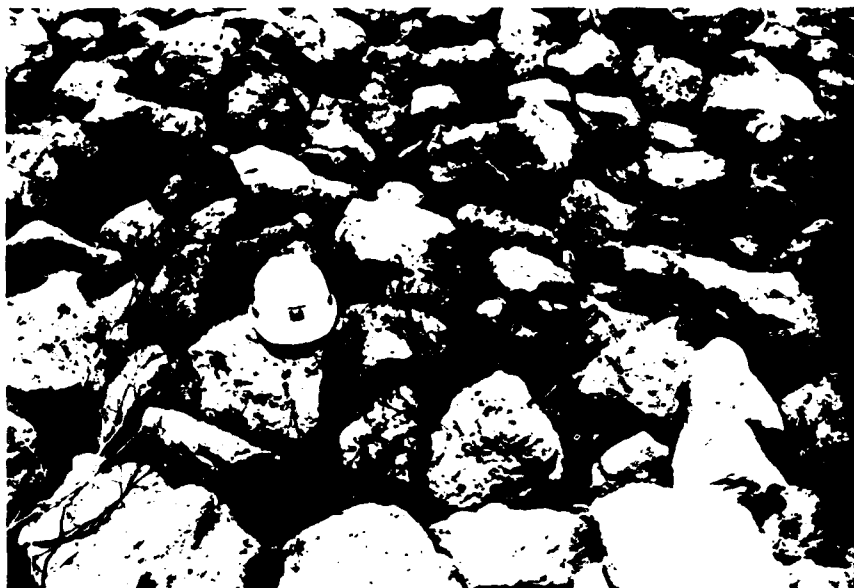
Figure 28. Republican River at Milford Dam Outlet Channel, Kans. There was good coverage of rock on the slope below the 30-in.-thick horizontal blanket at the time of the May 1977 inspection (Test Section 4). (Source: Reference 11)

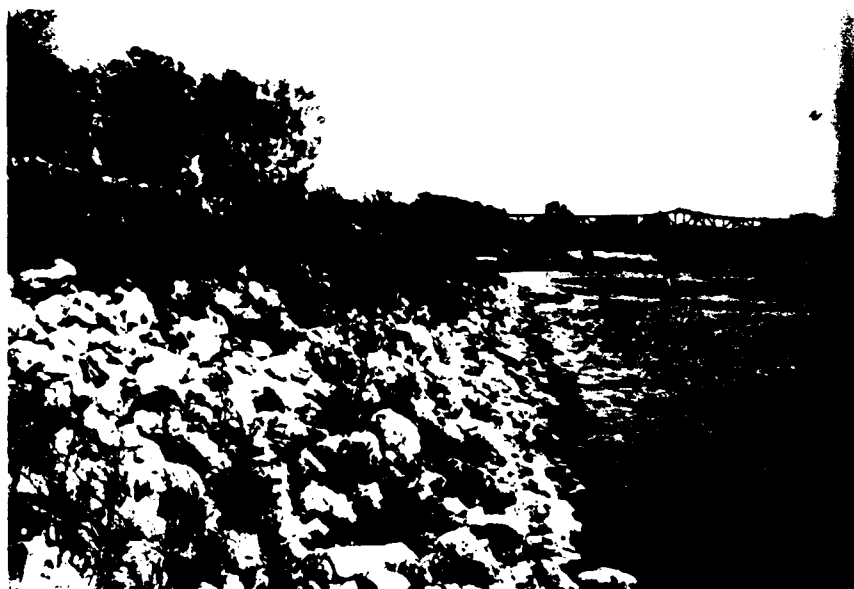
Figure 29. Republican River at Milford Dam Outlet Channel, Kans. There was a substantial growth of woody vegetation over Test Section 3 at the time of the May 1977 inspection. The view is downstream toward the U. S. Highway 77 Bridge. (Source: Reference 11)

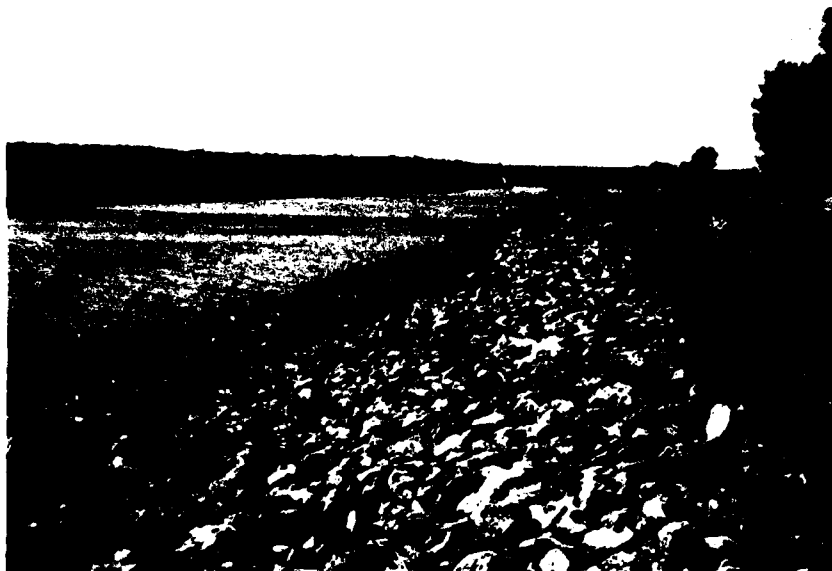
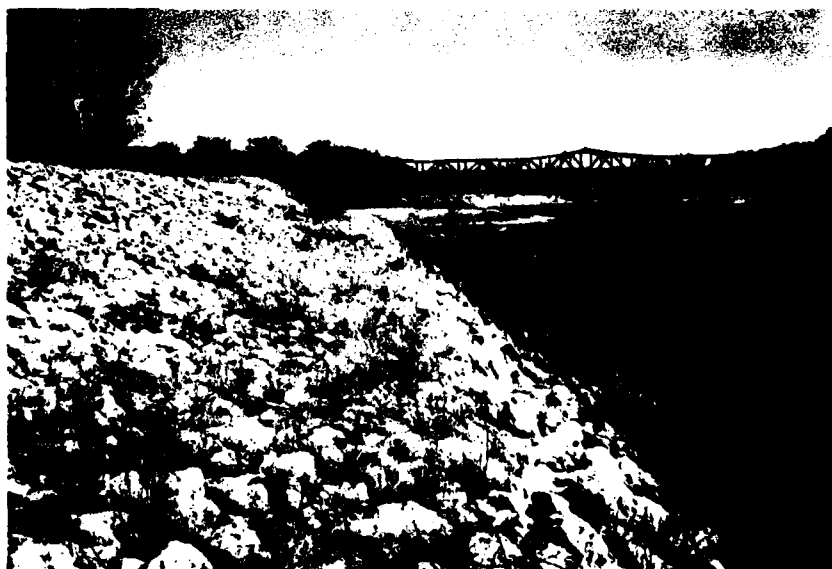
39. The WES Section 32 team visited the site on 18 September 1978. Figure 30 shows upstream and downstream views of the revetment in the outlet channel. The team found the side-slope revetment to be performing as designed; no apparent failures were noted. Later visits to the site by MRK through January 1980 indicate that the revetment continues to perform well.

Figure 30. Republican River at Milford Dam Outlet Channel, Kans. Upstream and downstream views of the outlet channel revetment at the time of the WEC inspection visit. Note that the vegetation has been removed in the lower view; compare with Figure 29.
(18 September 1978)

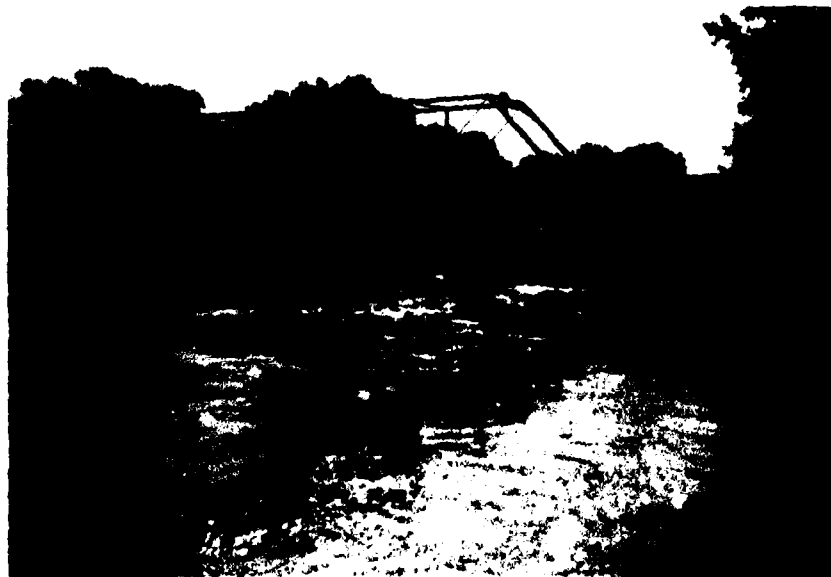
Figure 40. Big Blue River near Marysville, Kans. Downstream view from the end of dike at the time of the WEC inspection visit (12 September 1978).

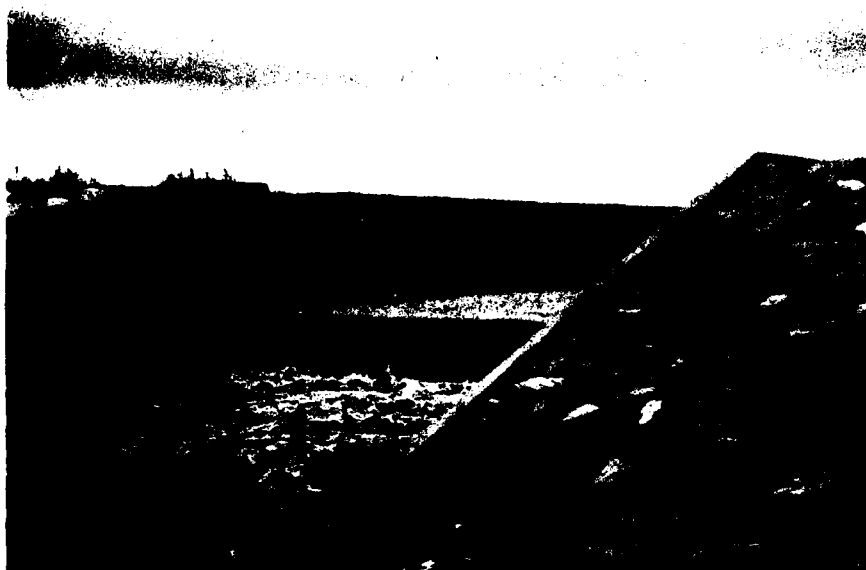
Figure 61. Little Sioux River at Onawa, Iowa. Damage to the stilling basin riprap as a result of high flows in April 1965 required the placement of grouted derrick stone to repair the basin

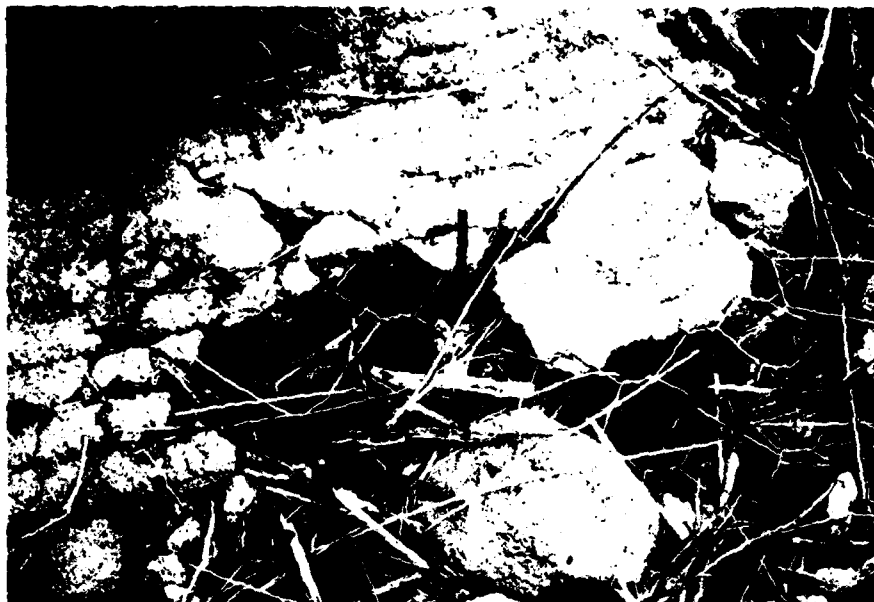
Figure 63. Little Sioux River at Onawa, Iowa. Loss of grout on left-bank mattress (20 September 1978)

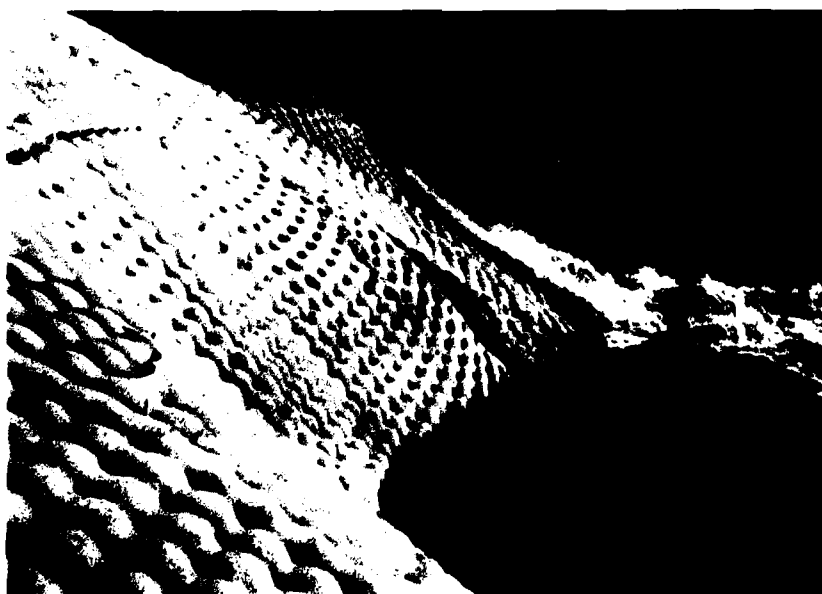
Figure 77. 10L River (East Fork) at Bedford, Iowa. High flows undercut the gabriiform mattress at the Bedford Water Treatment Plant resulting in subsidence of a section of the revetment. (21 September 1973)
